**University Terrace Berkeley**  
**General**  
***Berkeley, CA***

Report #: 48963-0  
Beginning: July 1, 2024  
Expires: June 30, 2025

**RESERVE STUDY**  
**"Full"**

March 15, 2024

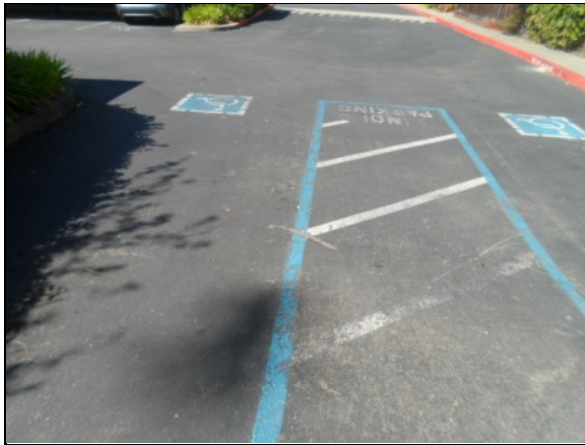
### Comp #: 202 Asphalt - Remove & Replace

Useful Life:  
35 years

Remaining Life:  
10 years
