**University Terrace Berkeley
General
Berkeley, CA**

Report #: 48963-1
Beginning: July 1, 2025
Expires: June 30, 2026

**RESERVE STUDY
Update "No-Site-Visit"**

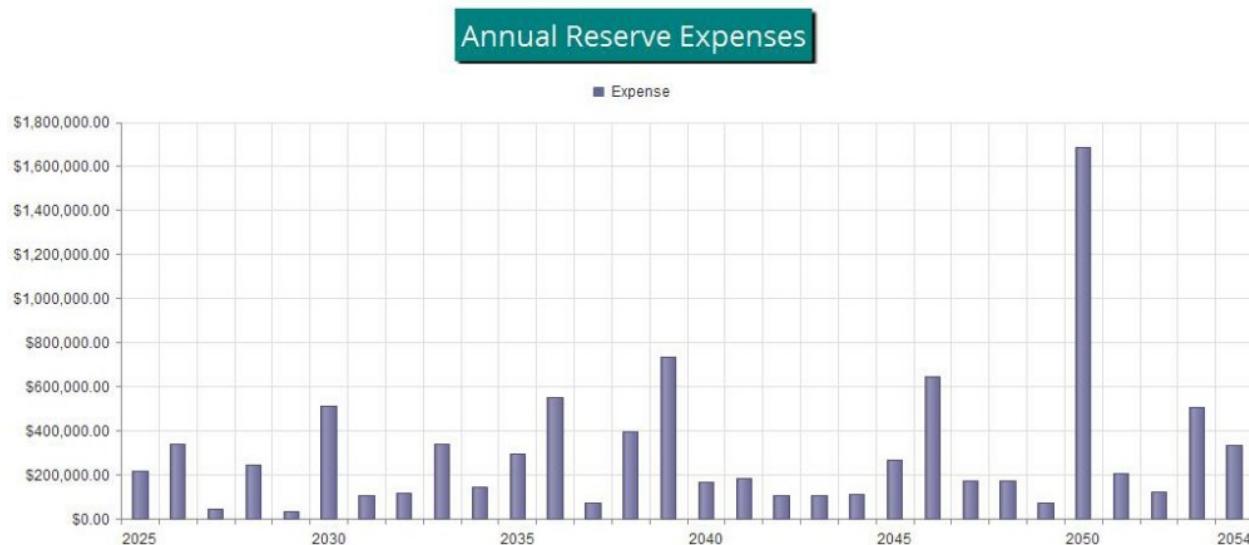
Figure 1

The figure below summarizes the projected future expenses at your property as defined by your Reserve Component List. A summary of these components is shown in the Component Details table, while a summary of the expenses themselves are shown in the 30-yr Expense Summary table.

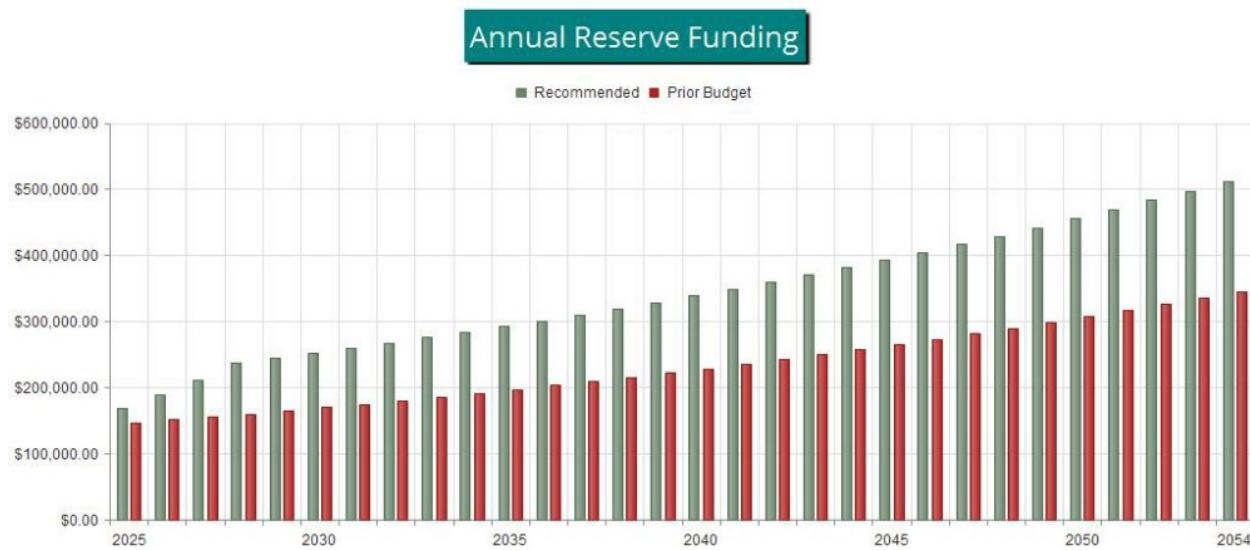
Figure 2

Based on your current Percent Funded and your near-term and long-term Reserve needs, we are recommending budgeted contributions of \$14,100/Monthly this Fiscal Year. The overall 30-yr plan, in perspective, is shown below. This same information is shown numerically in both the 30-yr Summary and the Cash Flow Detail tables.

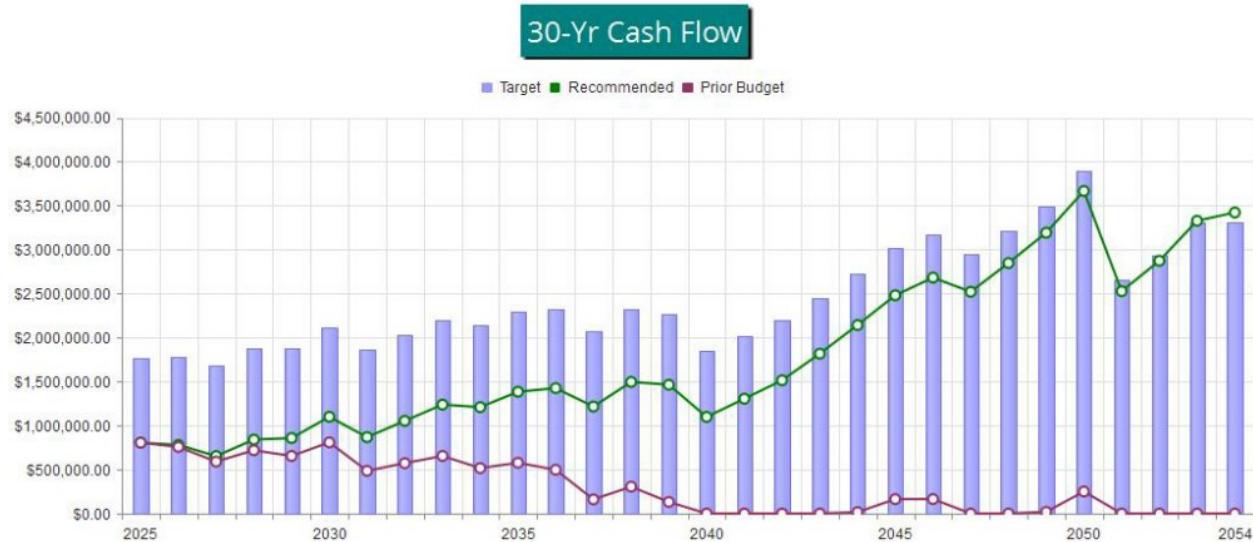
Figure 3

The following chart shows your Reserve balance under our recommended Full Funding Plan and at your current budgeted contribution rate, compared to your always-changing Fully Funded Balance target.

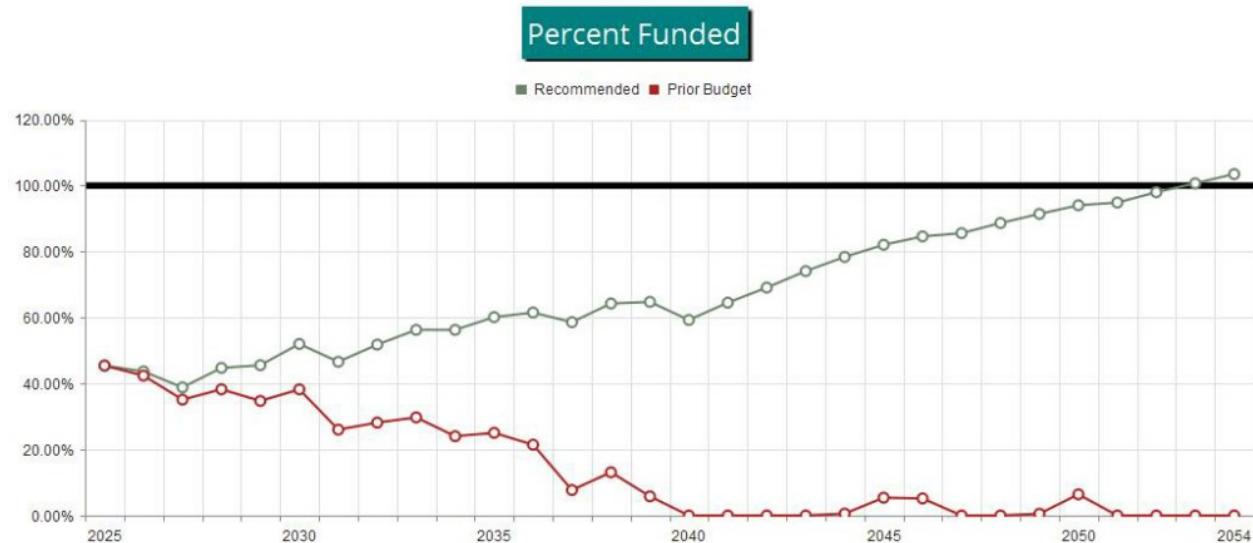
Figure 4

This figure shows the same information plotted on a Percent Funded scale. It is clear here to see how your Reserve Fund strength approaches the 100% Funded level under our recommended multi-yr Funding Plan.
