**University Terrace Berkeley
Building #9
Berkeley, CA**

Report #: 48963-1
Beginning: July 1, 2025
Expires: June 30, 2026

**RESERVE STUDY
Update "No-Site-Visit"**

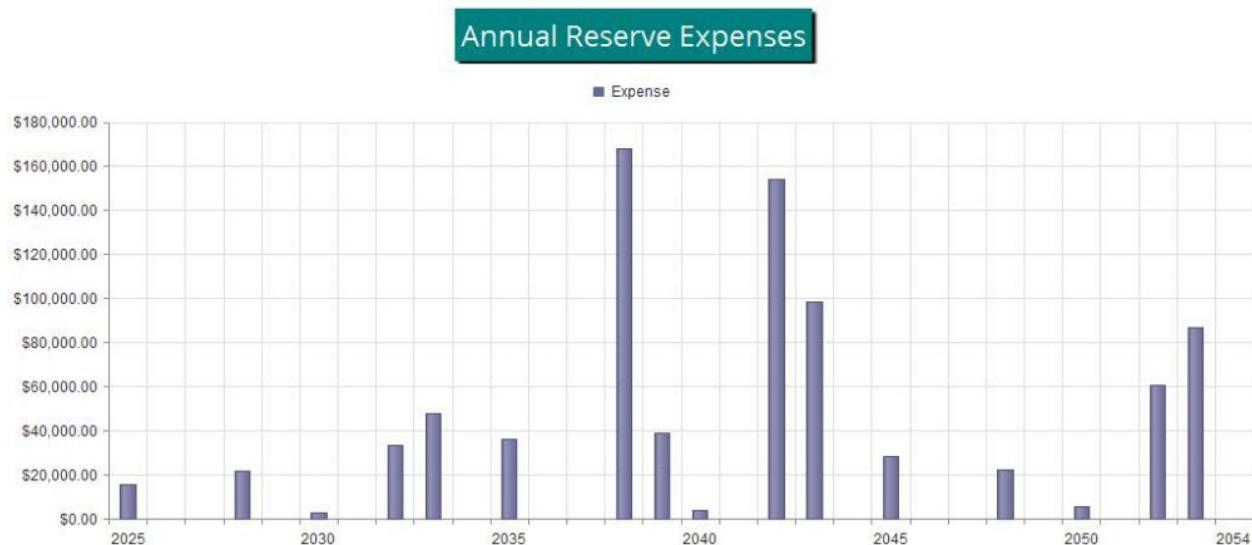
Figure 1

The figure below summarizes the projected future expenses at your property as defined by your Reserve Component List. A summary of these components is shown in the Component Details table, while a summary of the expenses themselves are shown in the 30-yr Expense Summary table.

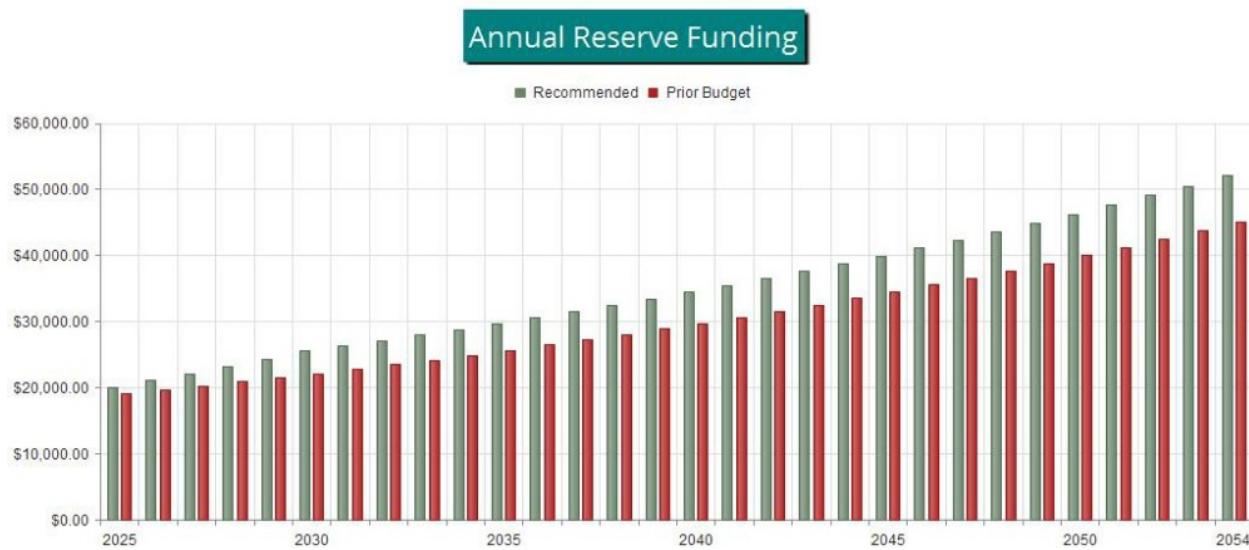
Figure 2

Based on your current Percent Funded and your near-term and long-term Reserve needs, we are recommending budgeted contributions of \$1,672/Monthly this Fiscal Year. The overall 30-yr plan, in perspective, is shown below. This same information is shown numerically in both the 30-yr Summary and the Cash Flow Detail tables.

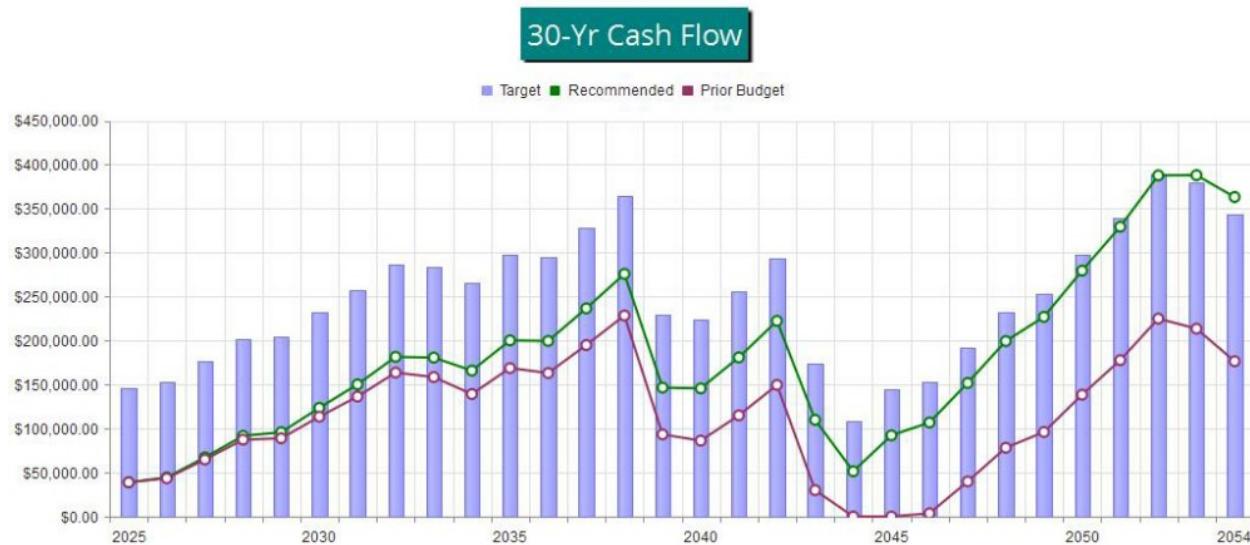
Figure 3

The following chart shows your Reserve balance under our recommended Full Funding Plan and at your current budgeted contribution rate, compared to your always-changing Fully Funded Balance target.

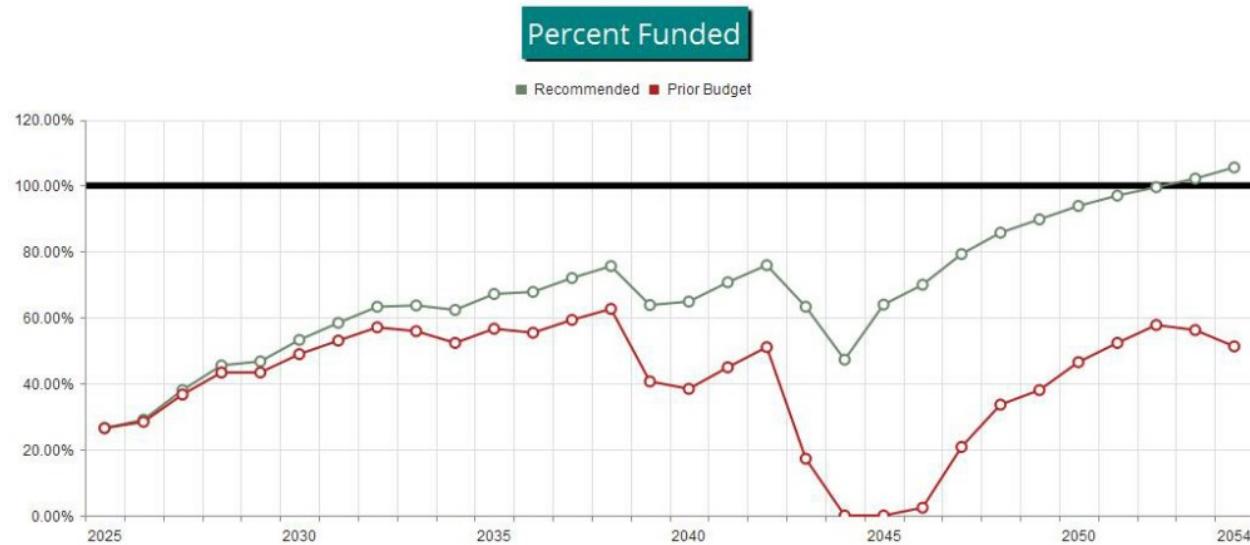
Figure 4

This figure shows the same information plotted on a Percent Funded scale. It is clear here to see how your Reserve Fund strength approaches the 100% Funded level under our recommended multi-yr Funding Plan.
