**University Terrace Berkeley**  
**General**  
***Berkeley, CA***

Report #: 48963-0  
Beginning: July 1, 2024  
Expires: June 30, 2025

**RESERVE STUDY**  
**"Full"**

March 15, 2024

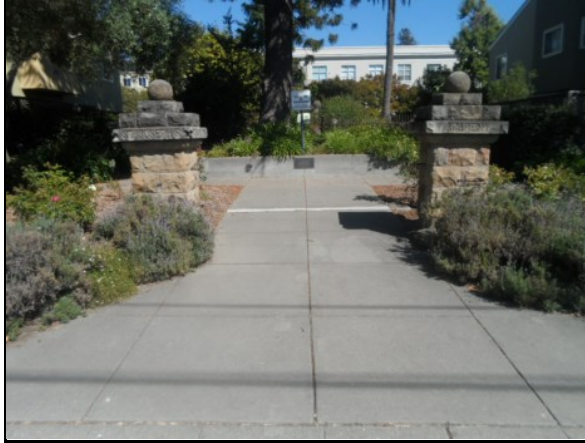
Useful Life:  
5 years

Remaining Life:  
4 years

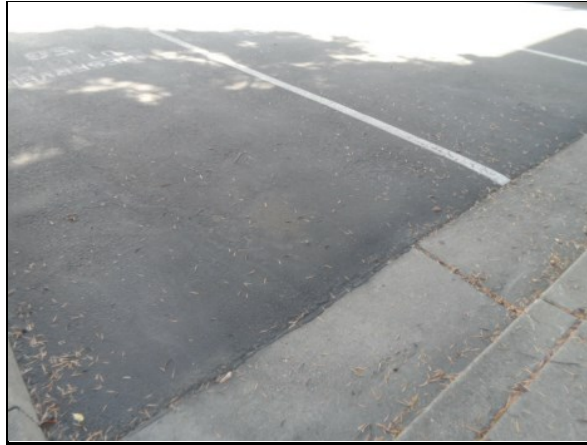
Useful Life:  
5 years

Remaining Life:  
0 years

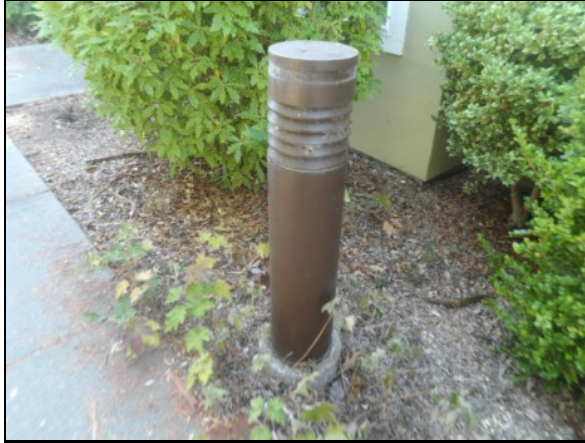
Useful Life:  
35 years

Remaining Life:  
9 years

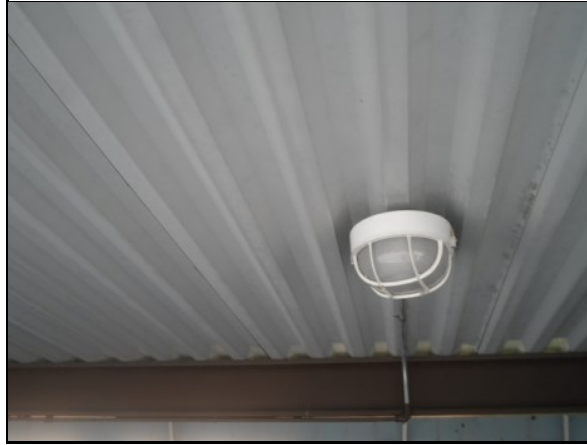
Useful Life:  
20 years

Remaining Life:  
10 years

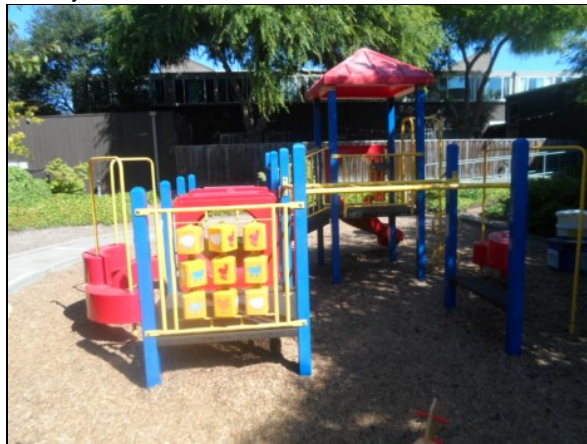
Useful Life:  
20 years

Remaining Life:  
1 years

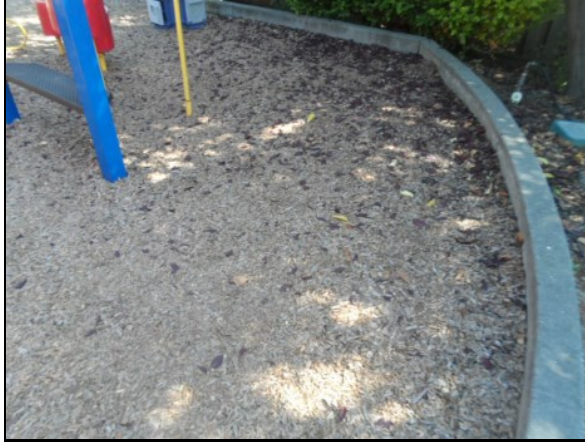
Useful Life:  
5 years

Remaining Life:  
1 years

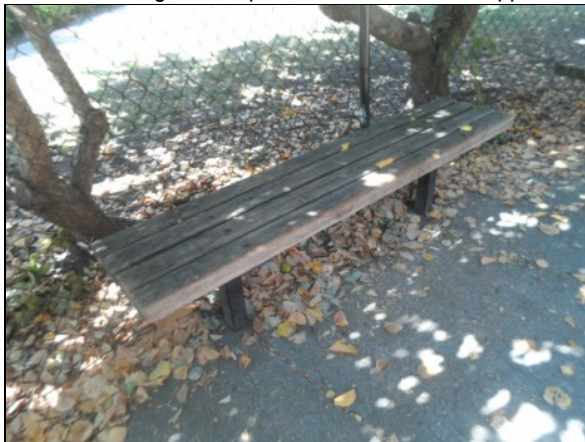
Useful Life:  
20 years

Remaining Life:  
10 years

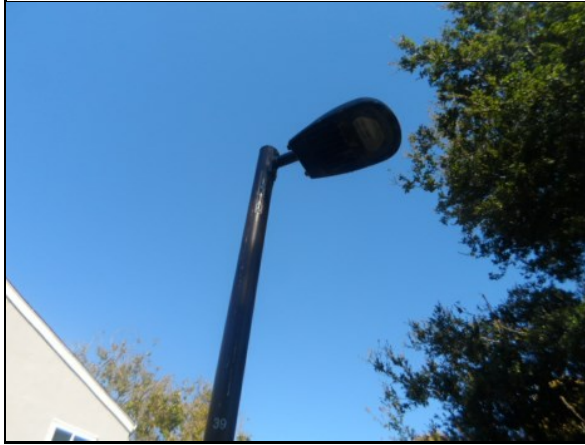
Useful Life:  
35 years

Remaining Life:  
9 years

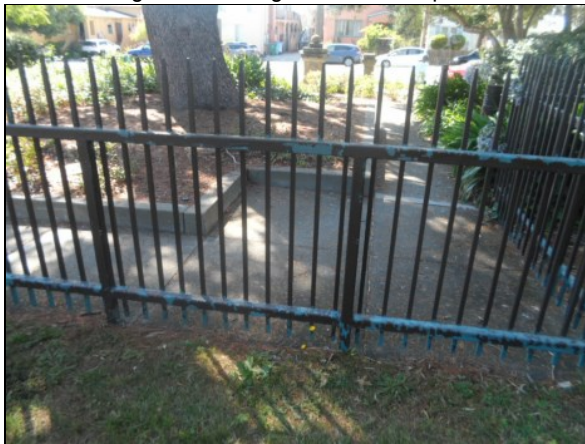
Useful Life:  
35 years

Remaining Life:  
10 years

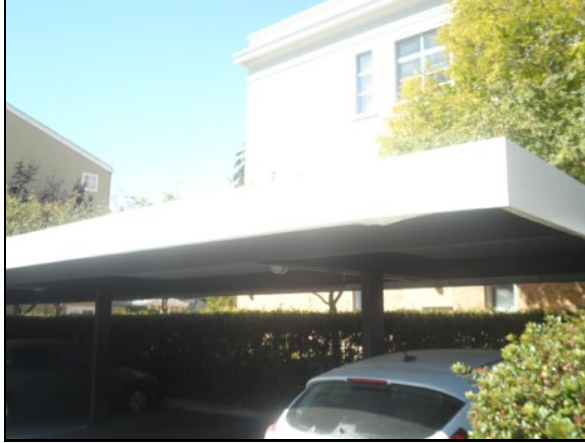
Useful Life:  
5 years

Remaining Life:  
0 years

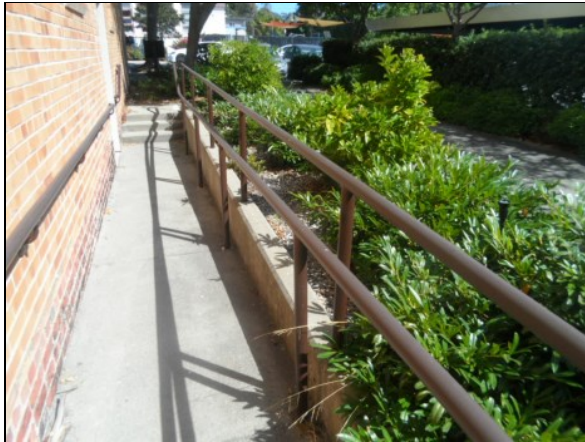
Useful Life:  
5 years

Remaining Life:  
0 years

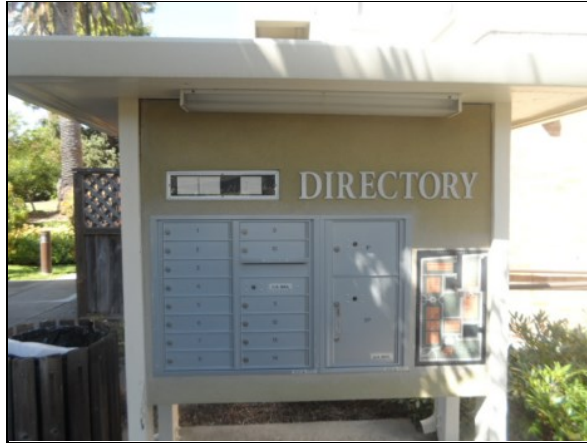
Useful Life:  
34 years

Remaining Life:  
24 years

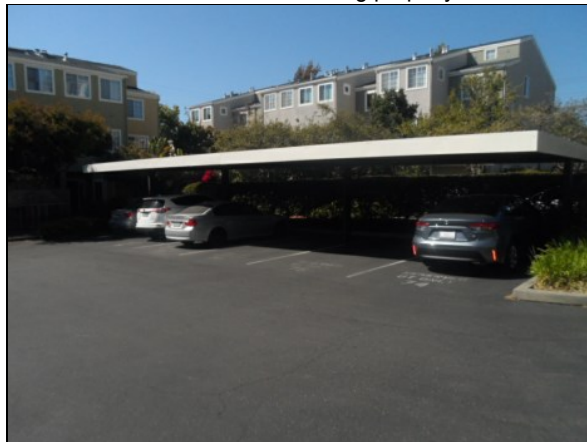
Useful Life:  
35 years

Remaining Life:  
9 years

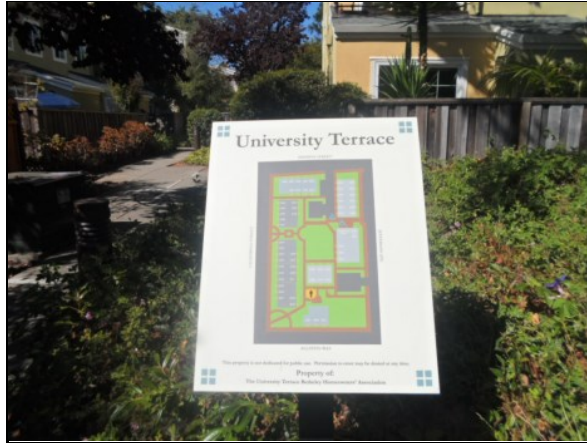
Useful Life:  
15 years

Remaining Life:  
1 years

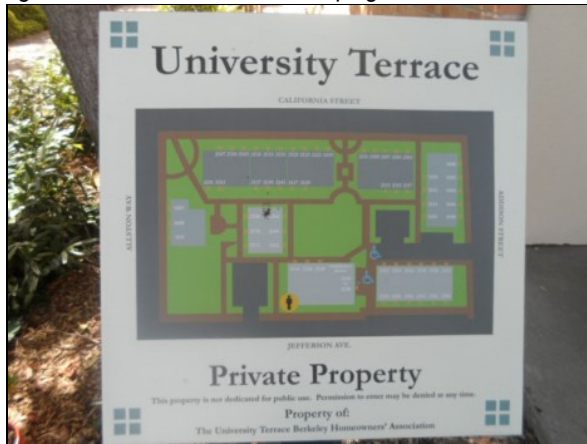
Useful Life:  
15 years

Remaining Life:  
9 years

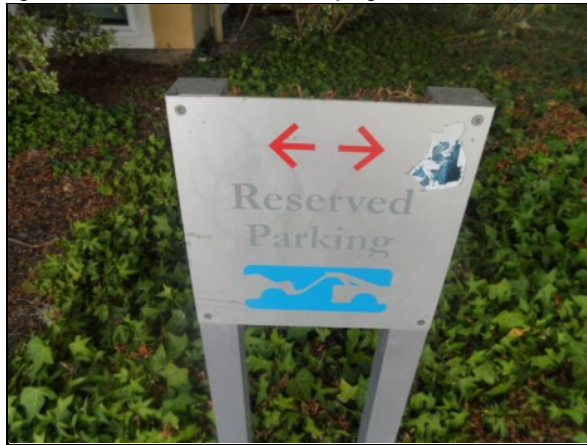
Useful Life:  
15 years

Remaining Life:  
1 years

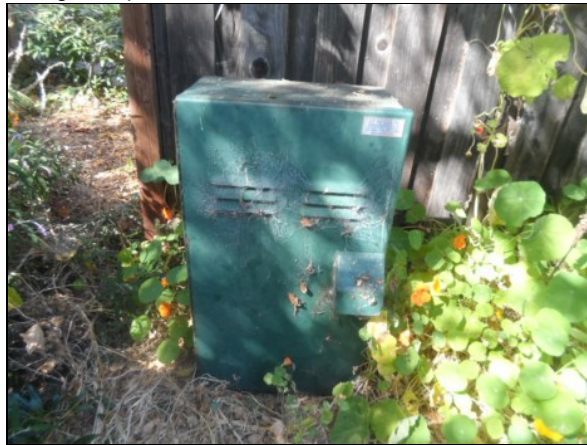
Useful Life:  
14 years

Remaining Life:  
0 years

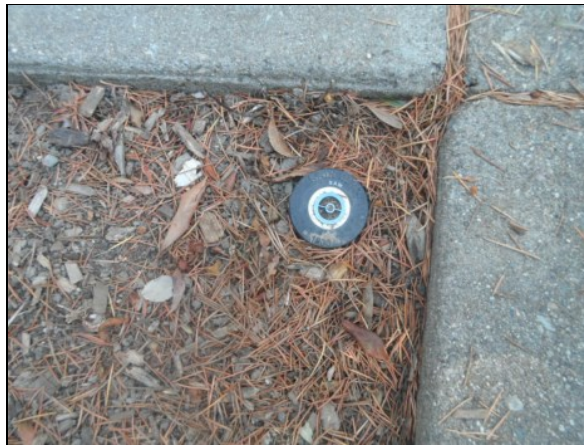
Useful Life:  
5 years

Remaining Life:  
0 years

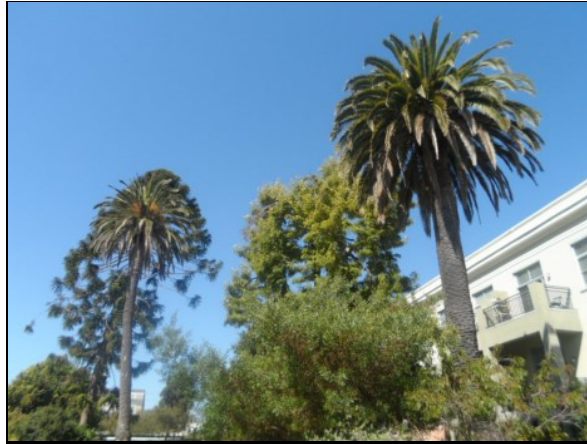
Useful Life:  
7 years

Remaining Life:  
1 years

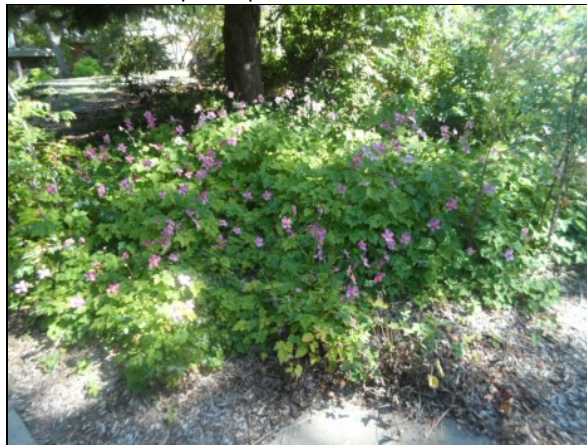
Useful Life:  
5 years

Remaining Life:  
0 years

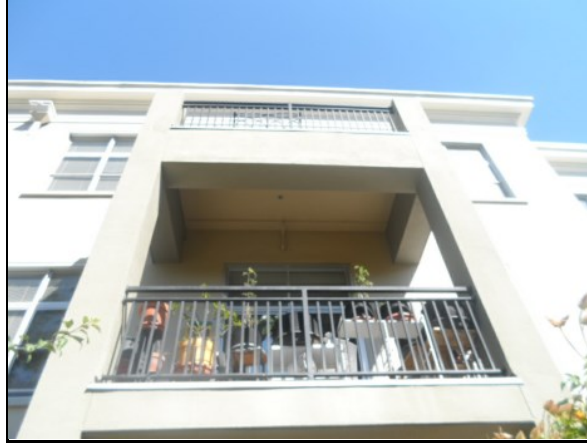
Useful Life:  
9 years

Remaining Life:  
8 years

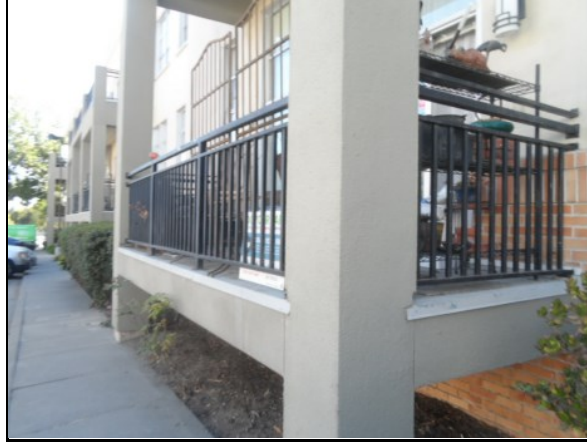
Useful Life:  
5 years

Remaining Life:  
4 years

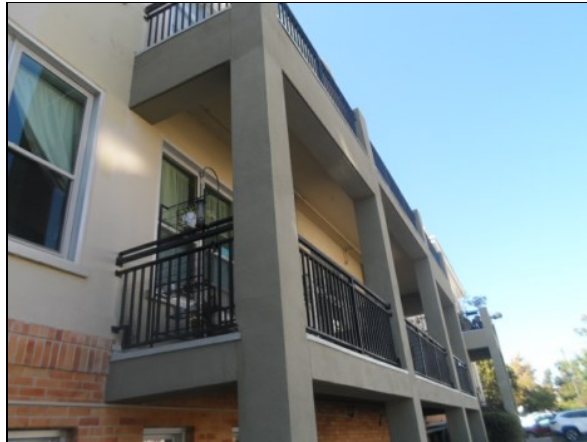
Useful Life:  
35 years

Remaining Life:  
9 years

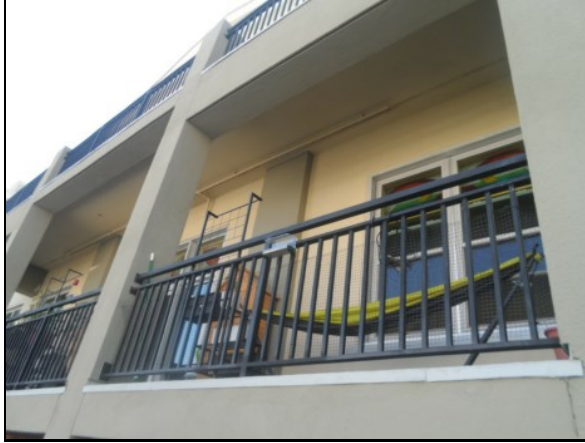
Useful Life:  
40 years

Remaining Life:  
14 years

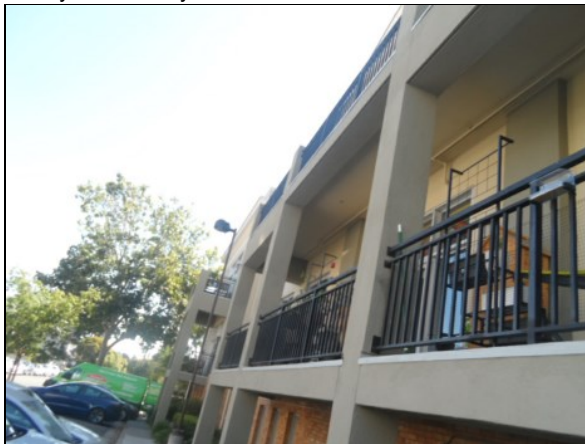
Useful Life:  
5 years

Remaining Life:  
0 years

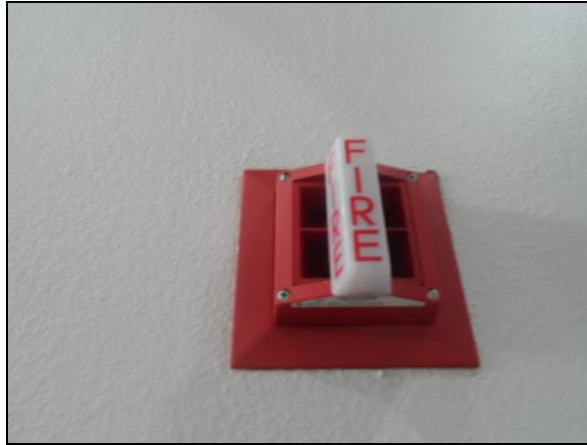
Comments: Unless otherwise noted, fire sprinkler/suppression distribution system (pipes, valves, sprinkler heads, etc.) is assumed to have been designed and installed properly and adheres to all relevant building codes. Generally speaking, repairs are minimal and infrequent and can be addressed as needed as an Operating expense, not through Reserves.

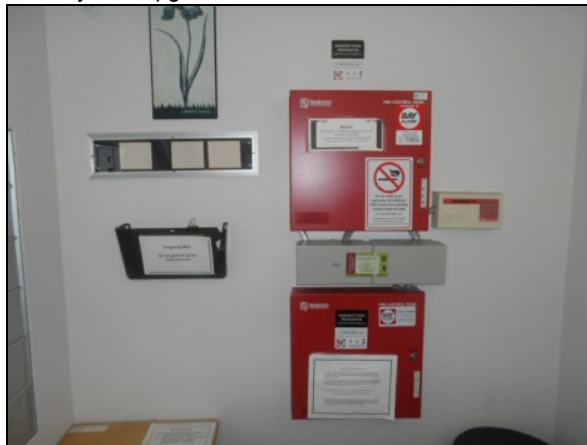
Comments: No current issues reported. We recommend periodic inspection by a licensed professional to ensure the system is functioning properly. Funding for a fire system upgrade at the interval below.

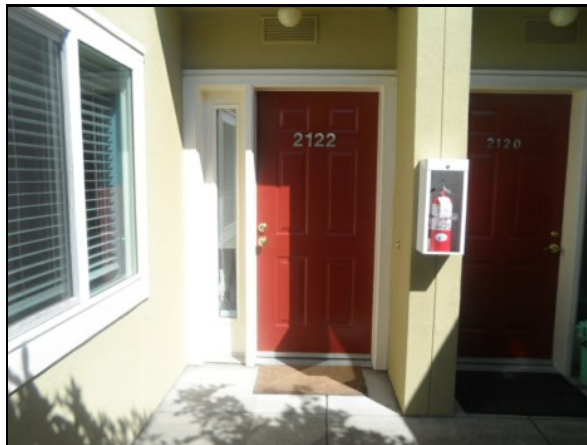
**Comp #: 1818 Fire Extinguishers/Cabinets-Replace**

Useful Life:  
30 years

Remaining Life:  
4 years

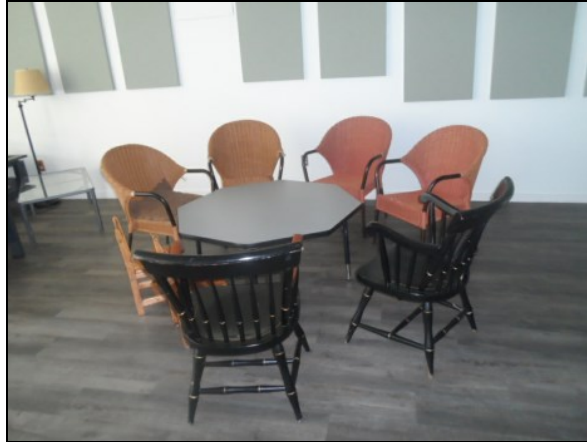
### Comp #: 404 Community Room Furniture - Replace

Comments: Inspect regularly and repair or replace any damaged pieces promptly to ensure safety. We recommend replacing all pieces together in order to maintain consistent style. Costs may vary based on quality of furniture selected for replacement.

Useful Life:  
15 years

Remaining Life:  
12 years

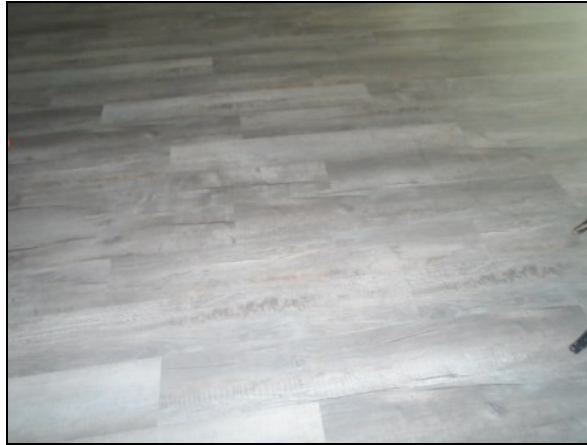
**Comp #: 602 Laminate Flooring - Replace**

Comments: Wide variety of type and quality available; a mid-range funding allowance is factored below for planning purposes. As part of ongoing maintenance program, professionally clean as needed. Plan to replace at the time frame below, best timed after interior repainting.

Useful Life:  
20 years

Remaining Life:  
18 years

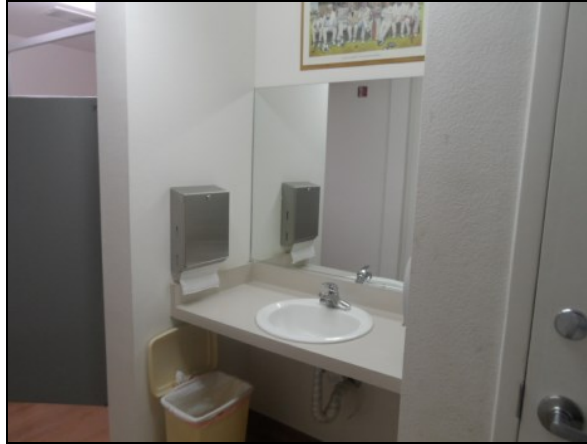
Comments: As routine maintenance, inspect regularly and perform any needed repairs promptly utilizing general Operating funds. Typical remodeling project can include some or all of the following: replacement of plumbing fixtures, partitions, counter tops, lighting, flooring, ventilation fans, accessories, décor, etc. The timing for refurbishment of the bathrooms is highly dependent on the level of aesthetics desired by the client. This component provides an allowance for general refurbishment at the interval indicated below.

Useful Life:  
30 years

Remaining Life:  
6 years

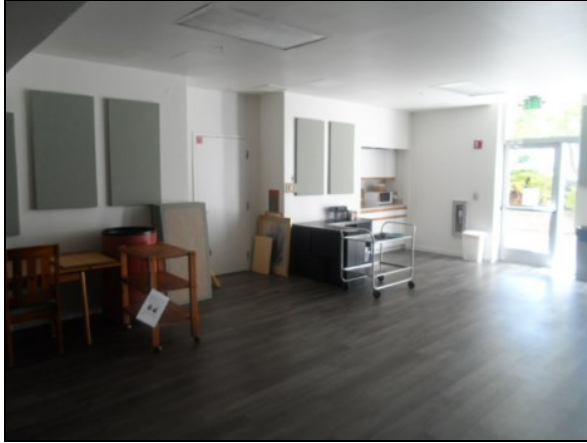
Comments: Regular cycles of paint are recommended to maintain appearance; best timed prior to carpet replacement. Keep touch-up paint on site for in between cycle projects.

Useful Life:  
10 years

Remaining Life:  
6 years
